Lord & Taylor, Rialto Sites Preliminary Investigations

Prepared by:

Topology

August 11, 2020

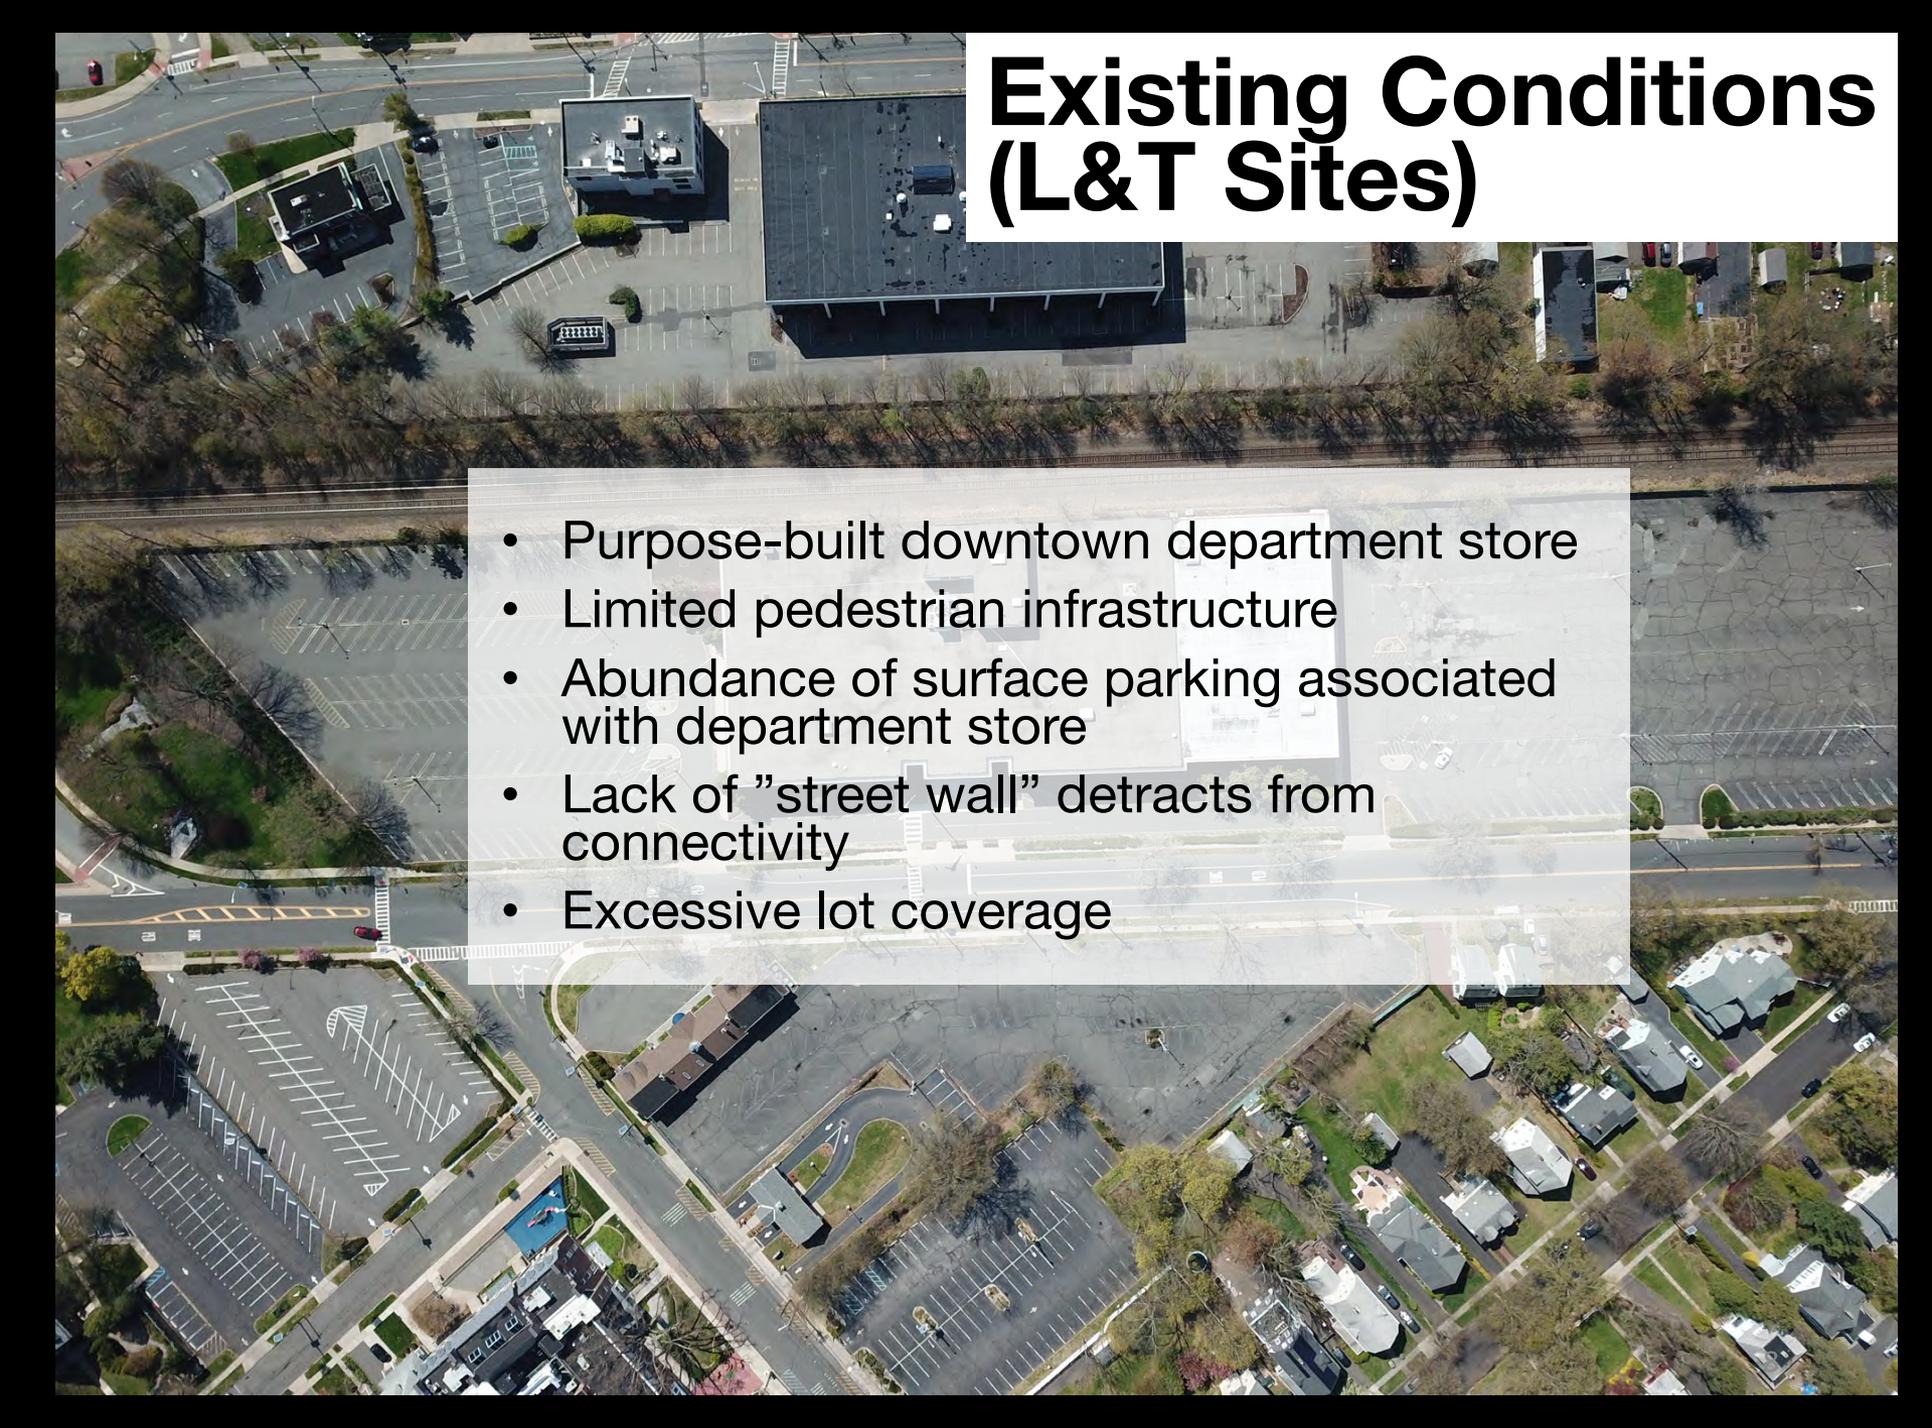
Existing Conditions (L&T Sites)

An aerial photograph of a downtown urban area. The top half of the image shows a large, dark-roofed building, likely a department store, with a large asphalt parking lot in front of it. A street wall runs along the front of the lot. Below the parking lot is a street with a crosswalk. The bottom half of the image shows a residential area with houses and smaller buildings, also with parking lots. A street with a crosswalk runs through the residential area. The overall scene illustrates the existing conditions of the L&T sites.

- Purpose-built downtown department store
- Limited pedestrian infrastructure
- Abundance of surface parking associated with department store
- Lack of "street wall" detracts from connectivity
- Excessive lot coverage

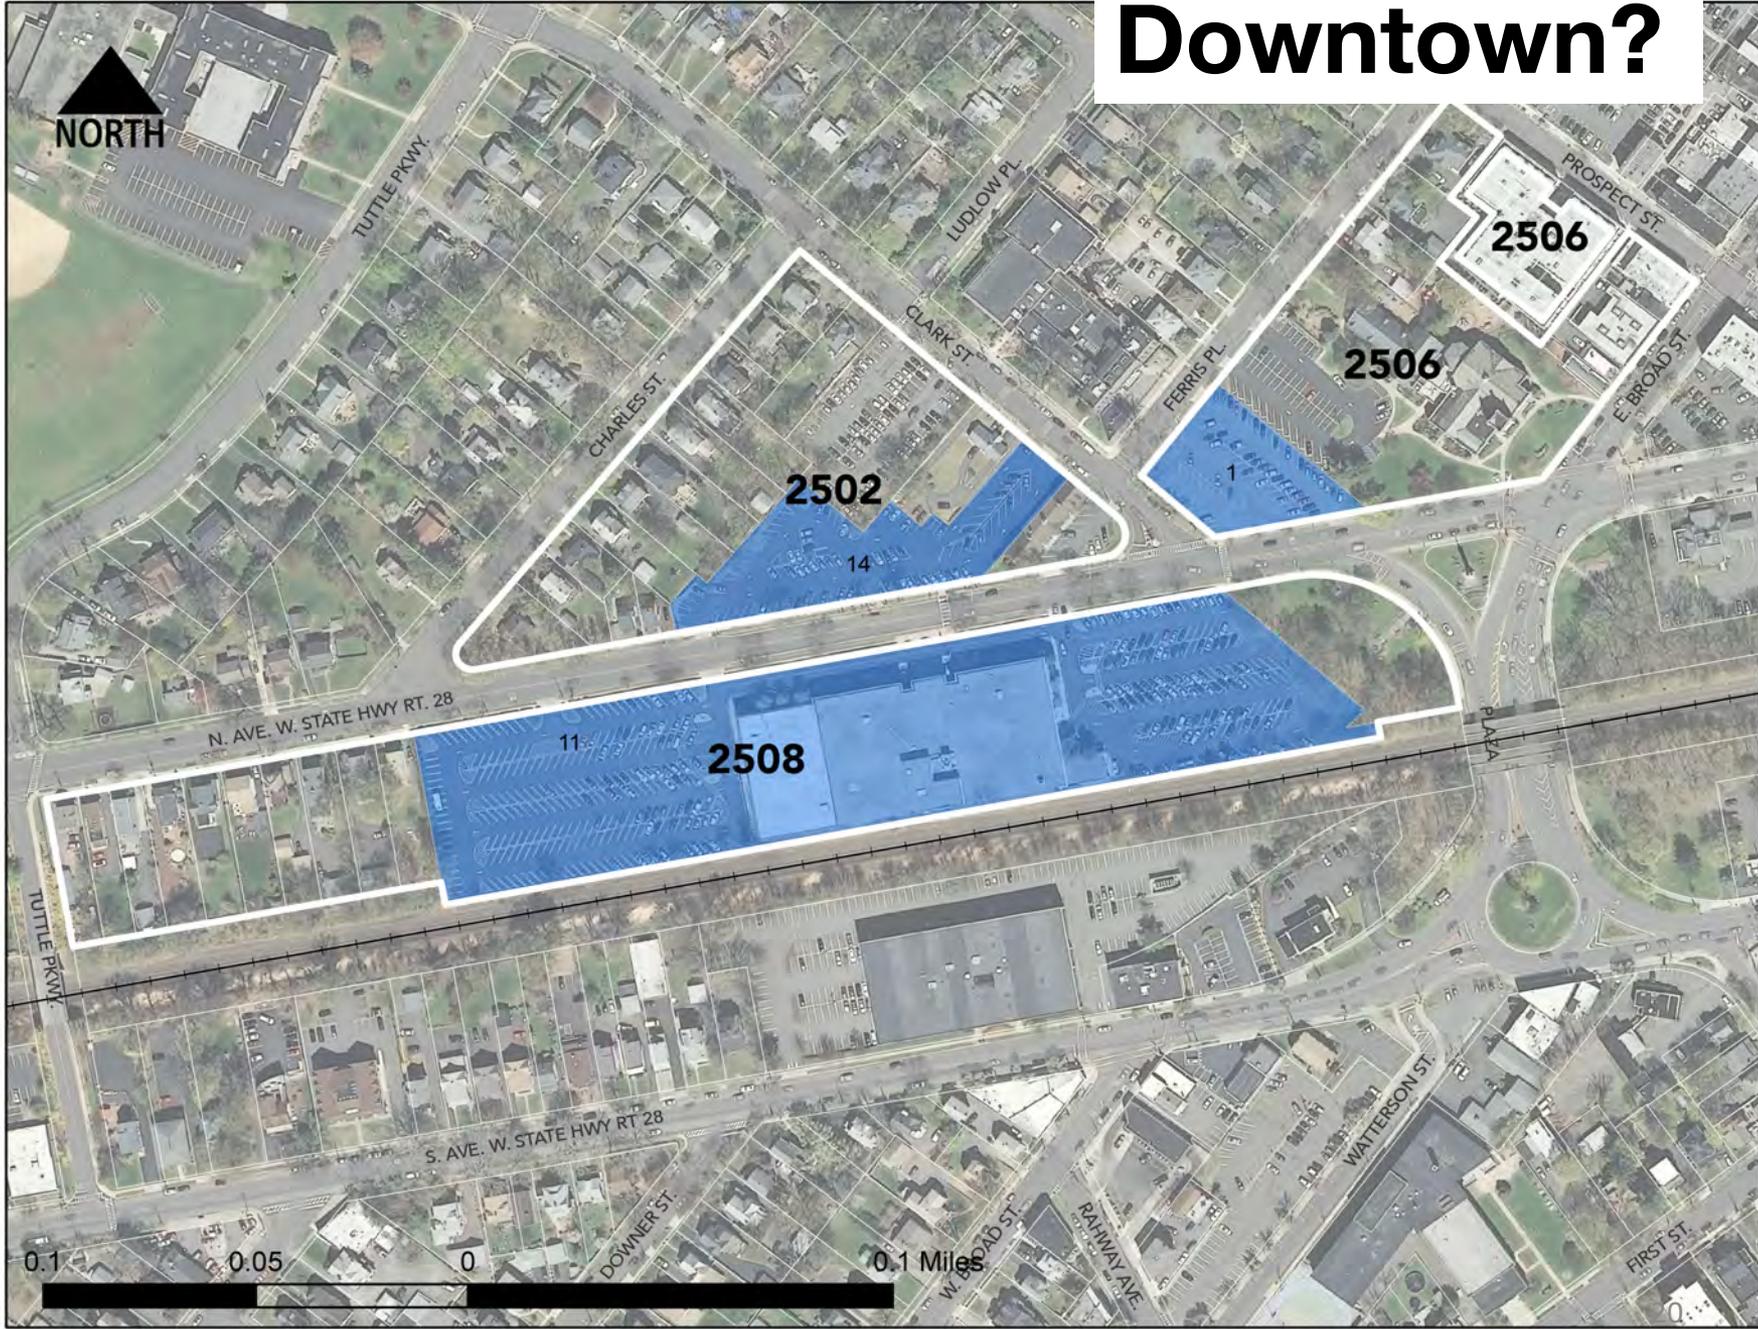
Downtown?

- In Concerned Citizens, Inc. v. Mayor and Council of the Borough of Princeton (Appellate Division, 2004), the Court upheld a finding that a downtown surface parking lot was evidence of obsolescence and qualified as an area in need of redevelopment under criterion D.
- Specific conditions, similar to those found in Westfield, were cited by the Court in Concerned Citizens:
 - Properties were located **downtown** where surface parking represented “yesterday’s solution” in a setting where “structured parking is the new standard.”
 - **Long-term efforts** had been underway to improve the downtown.
 - Parking lots inhibited the types of uses that would fulfill Princeton’s objectives and redevelopment was projected to “serve the **public health, safety, and welfare** of the entire community.”

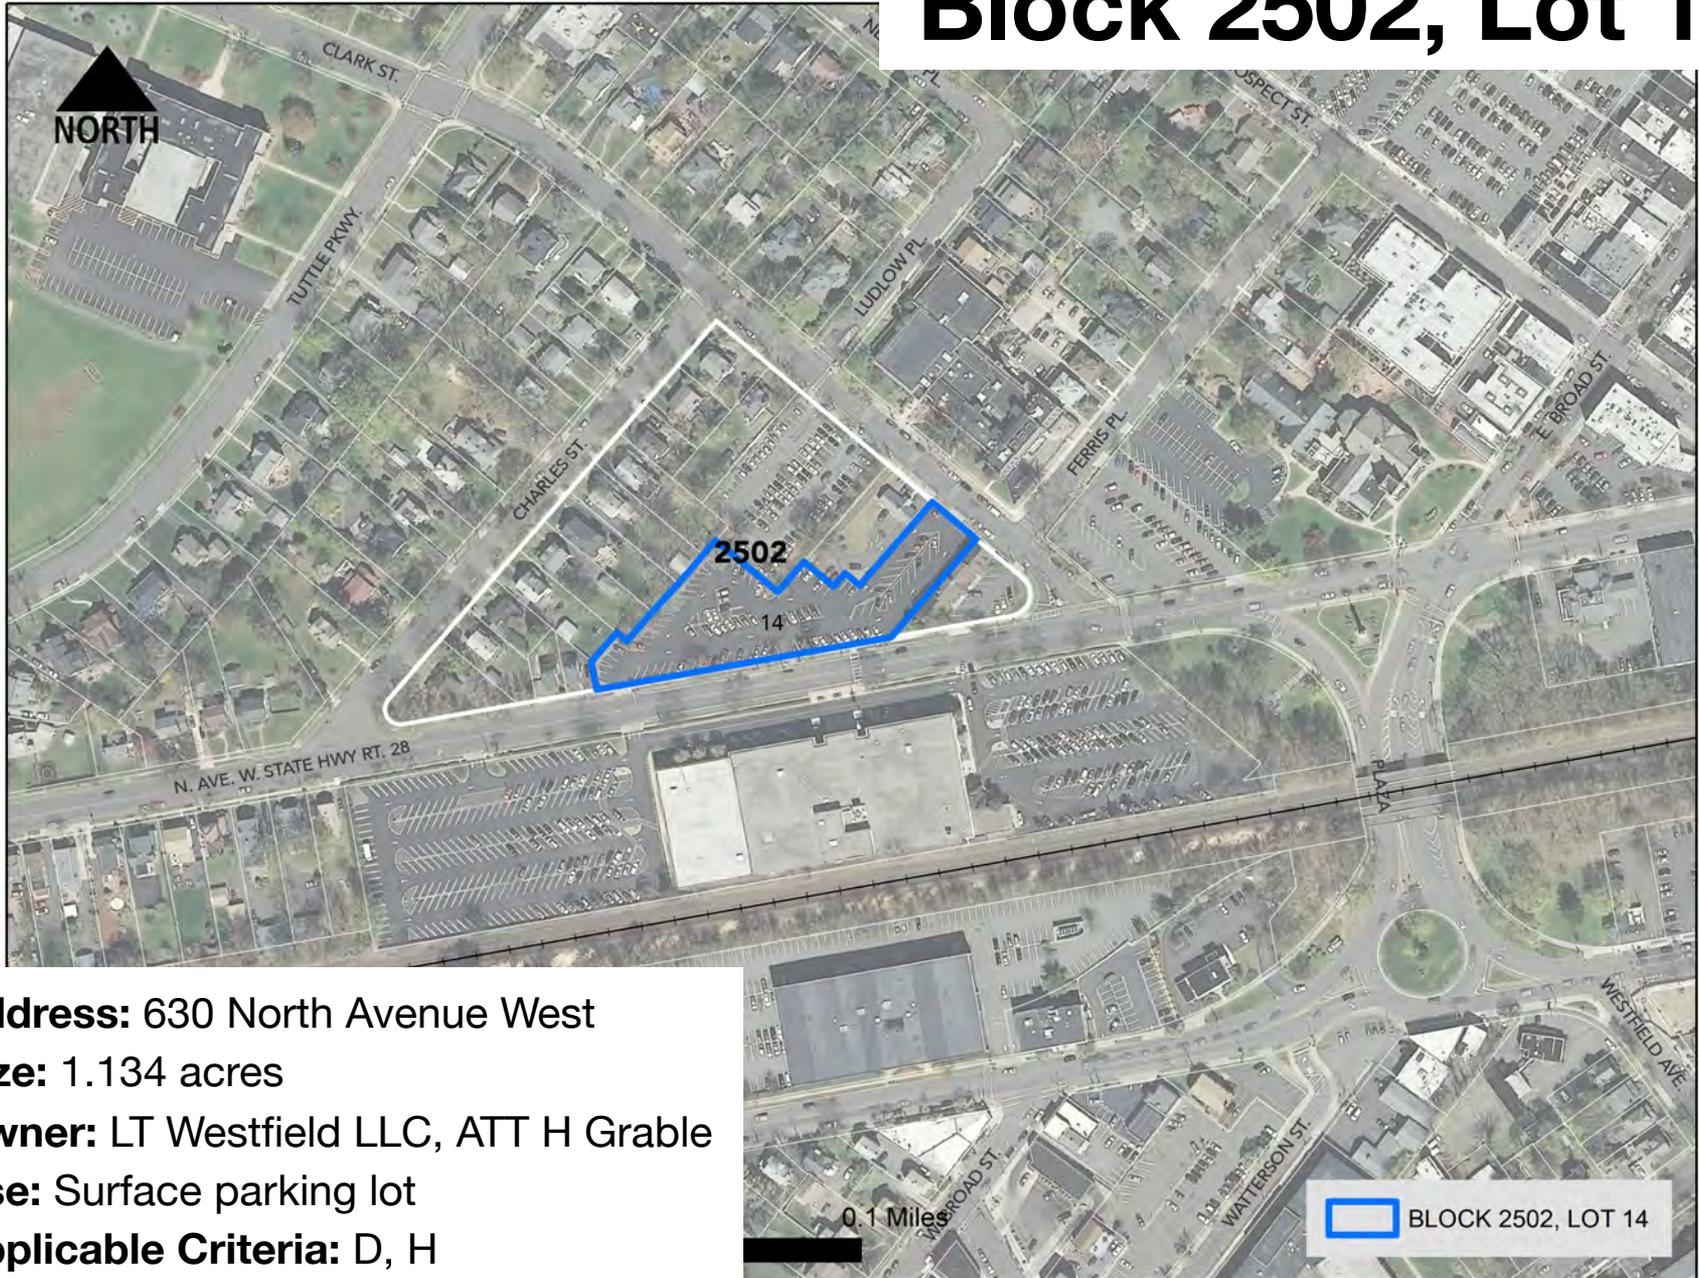
Block 2502, Lot 14

Address: 630 North Avenue West

Size: 1.134 acres

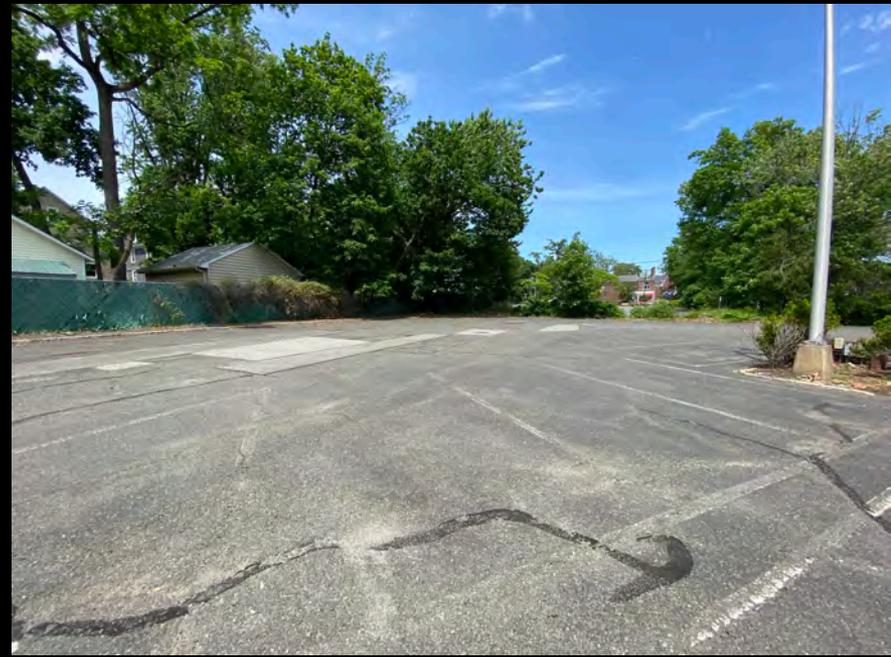
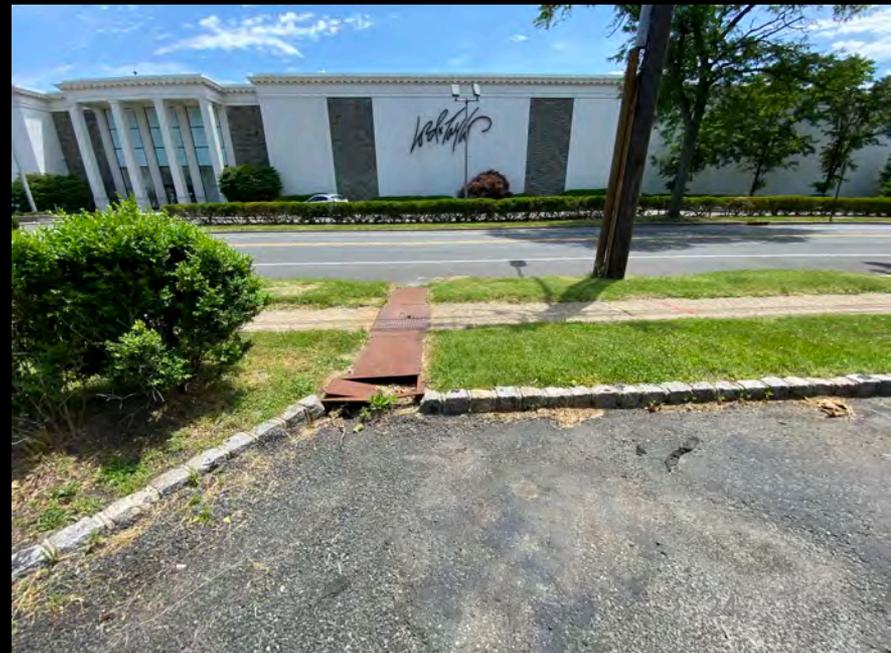
Block 2502, Lot 14

- **Detrimental to health, safety, welfare**
 - **Inefficiency (W)**
 - Single level of parking excludes other potential uses
 - One parking space per 504 square feet of area
 - **Noncontributory (W)**
 - No functional value besides providing 98 spaces
 - Improvement value per acre: \$44,709
 - Creates a break in the street wall (lack of transition)
 - **Design (H, S, W)**
 - Parking lot lacks or has partially visible striping and directional painting
 - No pedestrian striping for crossing the lot
 - Wide drive lanes and tight turns
 - Excessive lot coverage

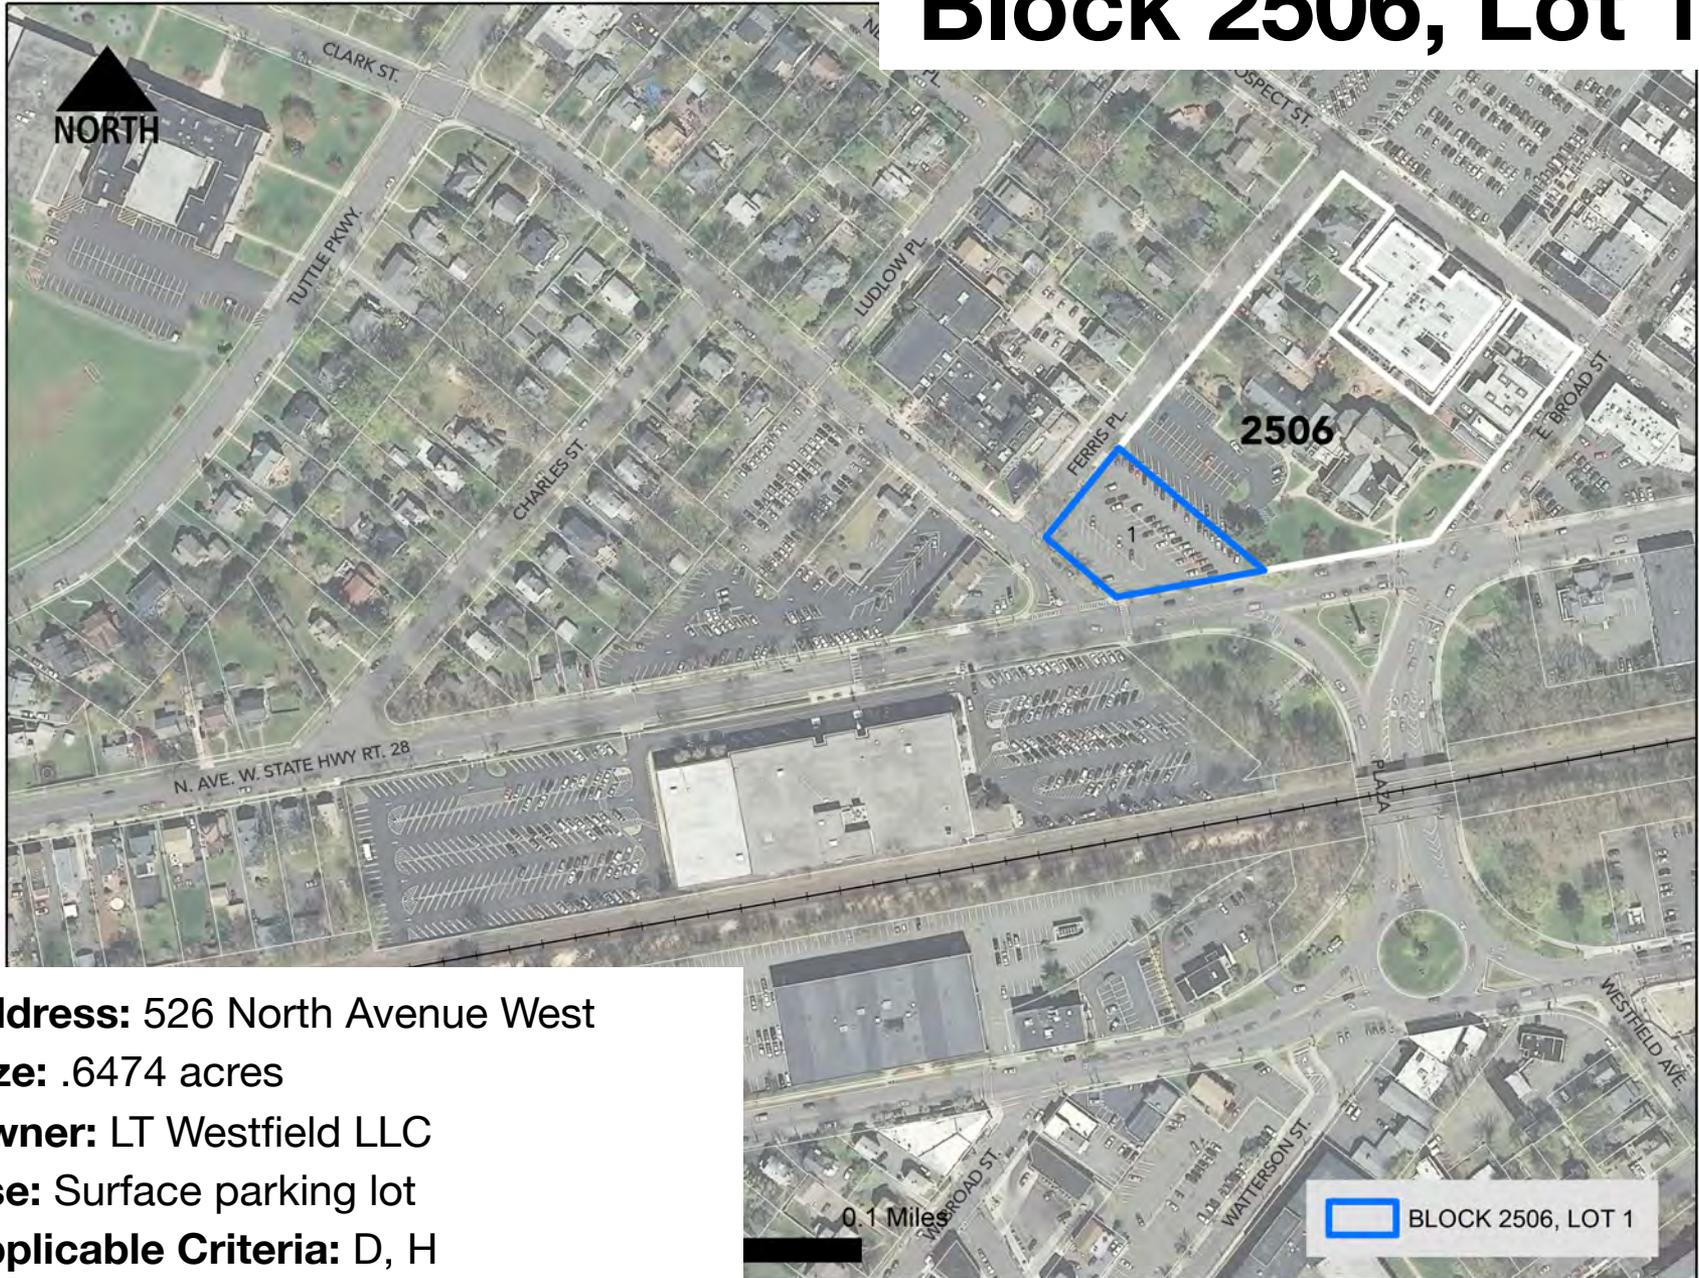
Block 2506, Lot 1

Address: 526 North Avenue West

Size: .6474 acres

- **Detrimental to health, safety, welfare**
 - **Inefficiency (W)**
 - Single level of parking excludes other potential uses
 - One parking space per 320 square feet of lot area
 - **Noncontributory (W)**
 - No functional value besides providing 88 spaces
 - Improvement value per acre: \$47,575
 - Creates a break in the street wall (lack of transition)
 - **Design (H, S, W)**
 - No pedestrian striping to facilitate safe crossings
 - Broken, missing, compromised curbing
 - Excessive lot coverage

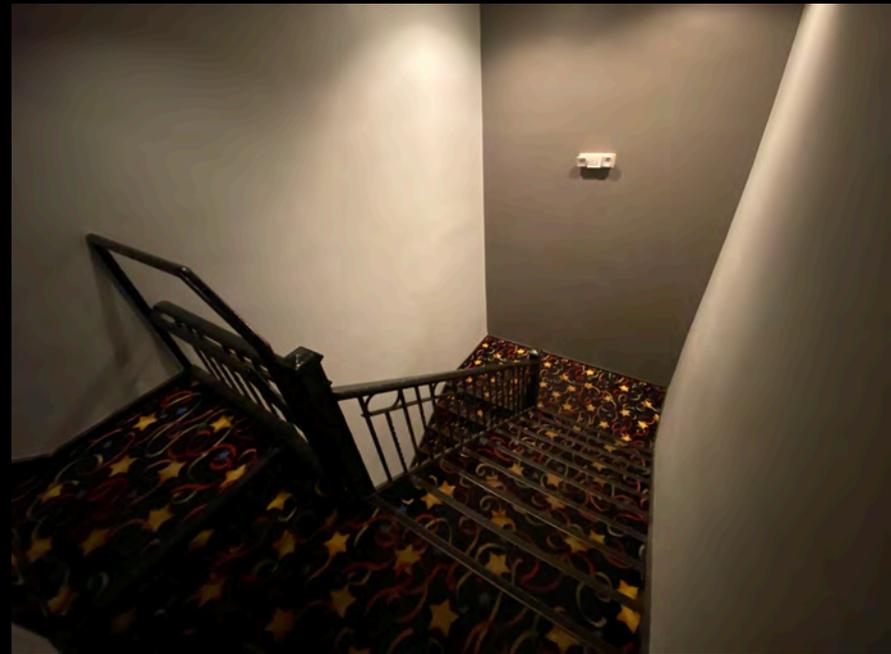
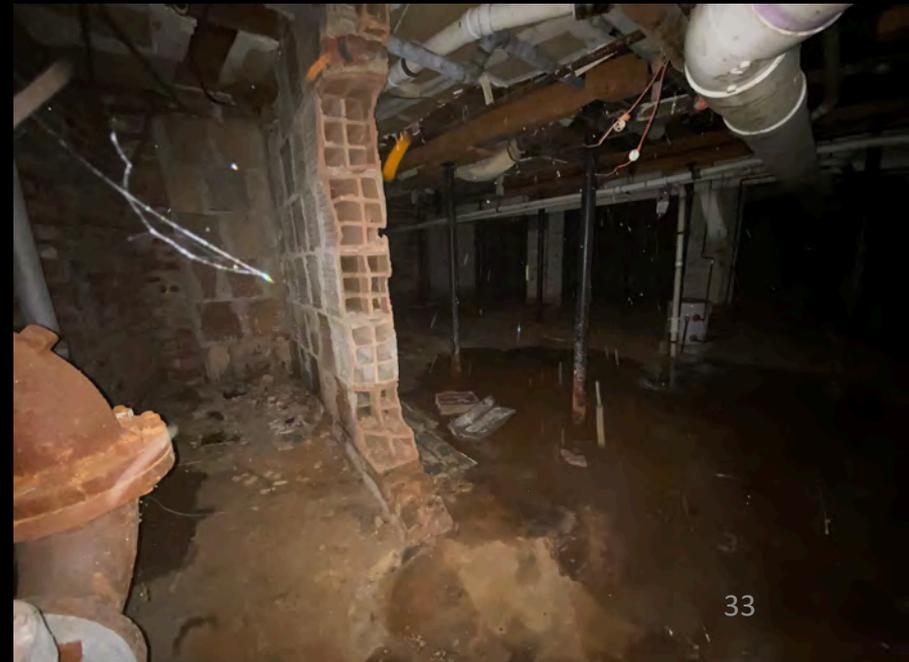
Criterion A

- **Generality of buildings are obsolescent and unsafe and, as a result, create unwholesome working conditions and health and safety risks for the general public.**
 - Haphazard wiring and equipment updates
 - Limited means of ingress and egress
 - Theatres are a “significant potential safety hazard” as per IBC
 - Site exhibits limited means of egress (narrow staircases, fire escape exits into narrow walkway)
 - Water intrusion
 - Standing water observed in basement
 - Water intrusion associated with mold growth
 - **Not** a recommendation for demolition

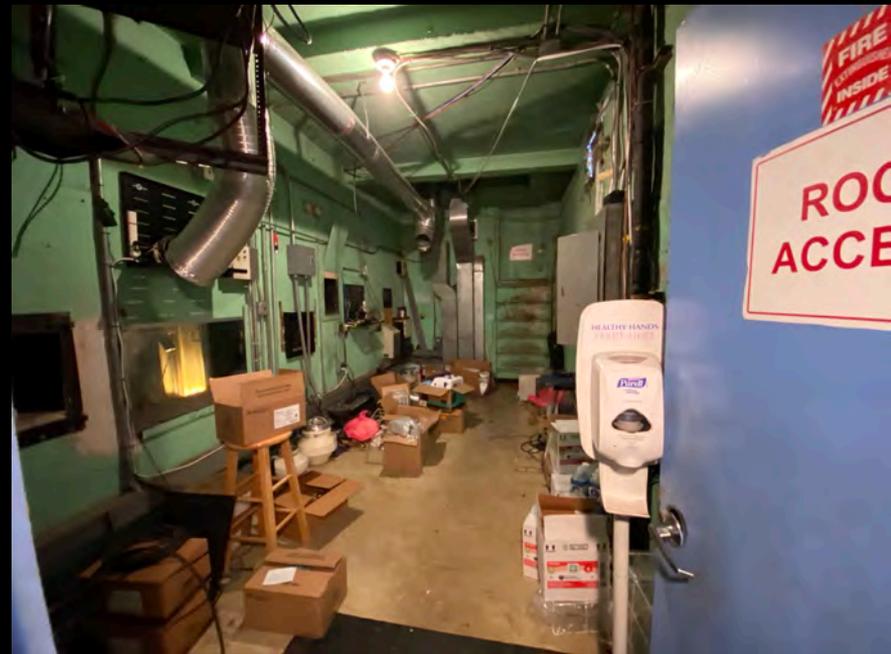
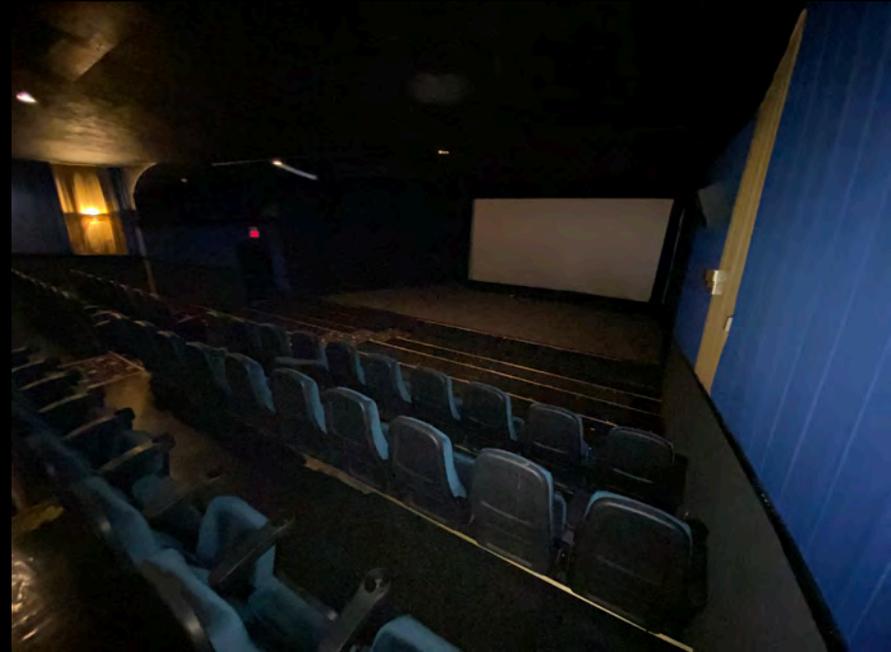
Criterion B

- **Building previously used for commercial use...that has been allowed to fall into so great a state of disrepair as to be untenable.**
 - Theatre is vacant and unsuitable for tenancy.
 - Major upgrades and system replacements necessary to function as a movie theatre
 - Lacks necessary infrastructure to function as a movie theatre (projection equipment, fixed seating in certain auditoriums)
 - Criterion A issues (ingress/egress, water intrusion, wiring) need to be addressed for tenancy.

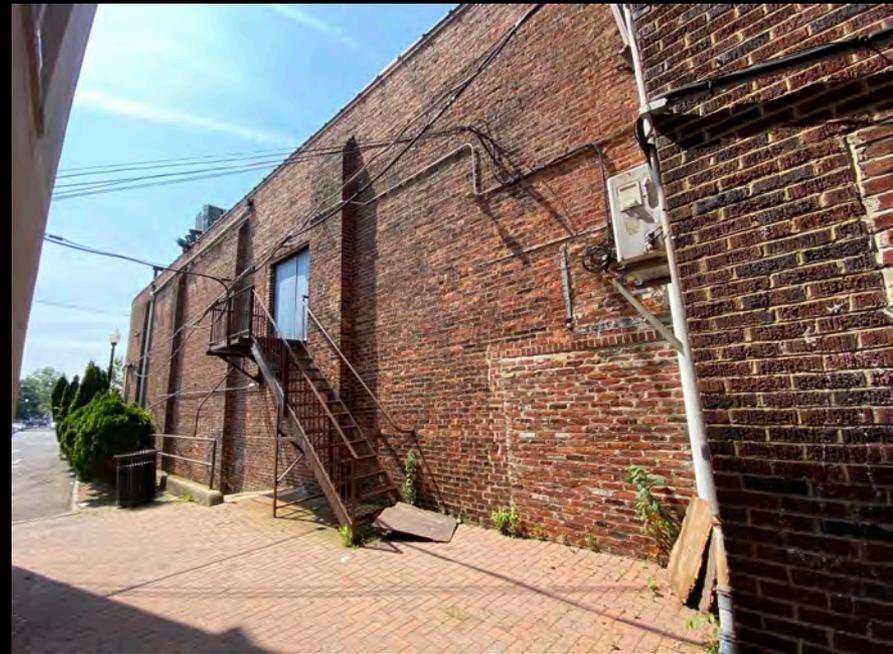
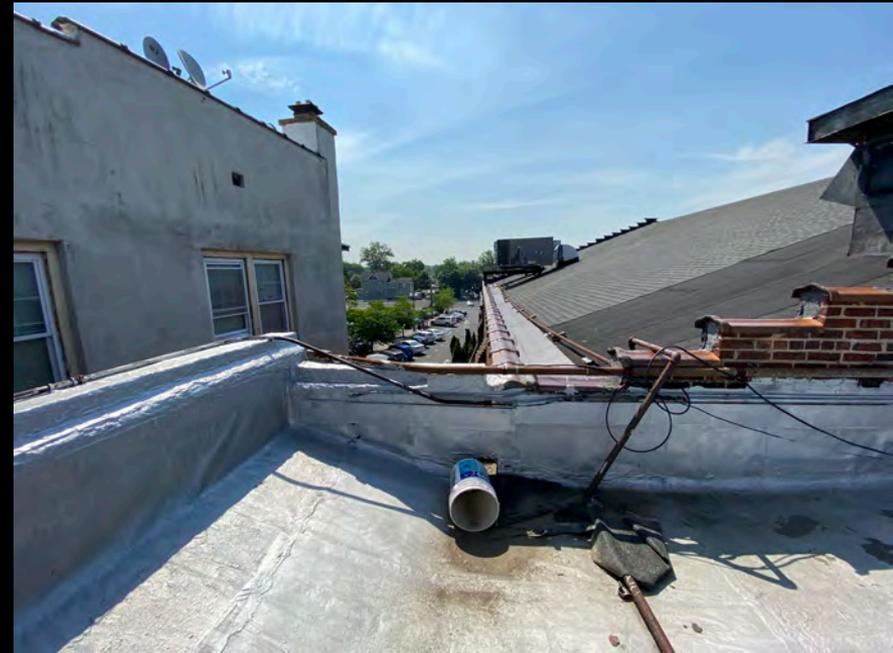
Criterion D

- **Characteristics of obsolescence, faulty arrangement, excessive land coverage, and obsolete layout, in a manner that is detrimental to the safety, health, and welfare of the community**
 - **Obsolescence: Lacks amenities and infrastructure found in successful modern theatres of similar scale.**
 - **Obsolescence evidenced in vacancy. Vacancy detrimental to welfare.**
 - **Obsolescence: Limited means of ingress/egress (faulty arrangement), haphazard wiring.**
 - **Detrimental to health, safety.**
 - **Excessive land coverage: Conducive to flooding, stormwater management issues**
 - **Detrimental to safety, welfare.**
